Manhole Inspection Summary

Manhole # S35K__024MH

Insp Date: **9/23/08 10:55 AM**

Location Address: **25 andrew place**

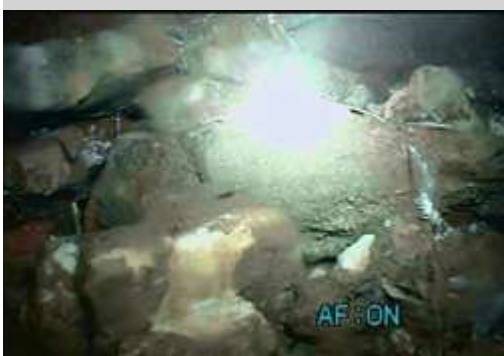
misc

bench debris

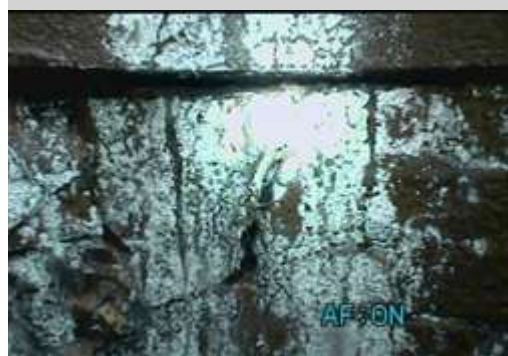
Defect 2

Condition: ☐ Sound ☒ **Cracked** ☐ Root Intrusion ☐ Loose Brick ☒ **Deteriorated**

crack in frame adj

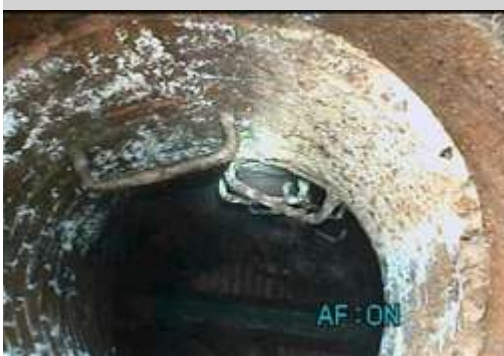
Defect 1

Steps Count: **6** Missing: **0** ☒ **Corroded**

cor. steps

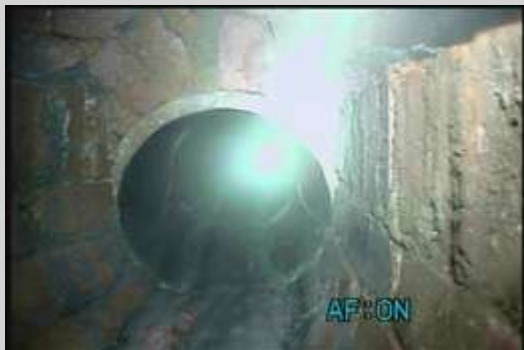
12 O'Clock Outflow

couldnt get better pic due to steam
